Marketing Research Division
Agricultural Marketing Service
U. S. DEPARTMENT, OF AGRICULTURE

July 1959

SHIPPING CONTAINERS FOR FROZEN TOM TURKEYS

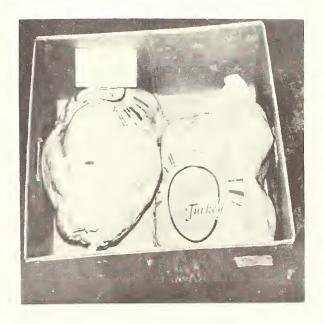
Figure 1.-- The five containers packed with tom turkeys for test shipments Neg. A- BN 8022, B- BN 8030, C- BN 8021, D- BN 8028, and E- 8025

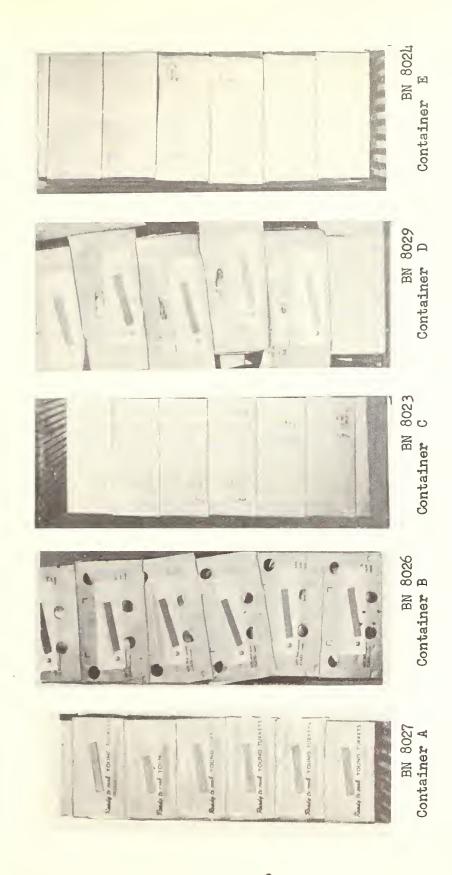
Concave tops accounted for about two-thirds of the number of boxes damaged. This condition seemed to result primarily from overhead weight, and occurred most frequently when the boxes were too deep for their contents, with excessive headroom between the top surface of the product and the top of the box.

Container D rated fourth, with 74 containers damaged, or about 42 percent of the 178 boxes tested. Concave tops were noted on 40 containers, creasing on 30, bulging on 3, and crushing on 1 (table 2). The pack varied from fairly tight to loose. Headroom varied from 3/4 to 2 inches; about 90 percent measured 1 inch or more (fig. 2). In width this container fit fair, in length it was too slack, and in depth it was too deep for the turkeys.

Container B held up the least well. There were 11.7 B-type containers in the experiment, and 97 of them, or about 66 percent, were damaged; 86 had concave tops, 70 of which were moderately damaged and 16 slightly damaged; 6 others were crushed slightly, 3 slightly creased, 1 slightly bulged, and 1 slightly scuffed (table 2). The turkeys did not fit the container well, the pack was loose, and the container was generally too large for its contents. There were from $1\frac{1}{2}$ to $2\frac{1}{2}$ inches of excess space between the top surface of the turkeys and the tops of the boxes. In about two-thirds of the containers, the slack measured 2 inches or more (fig. 2).

Figure 2.--Stacks of five different containers in truck at Eastern terminal after cross-country haul. Containers C and A sustained the least damage and containers B and D the most damage.
